The mundic problem

3rd edition

RICS guidance note, UK

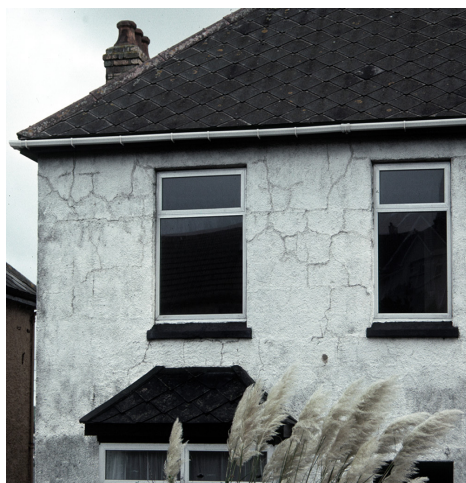
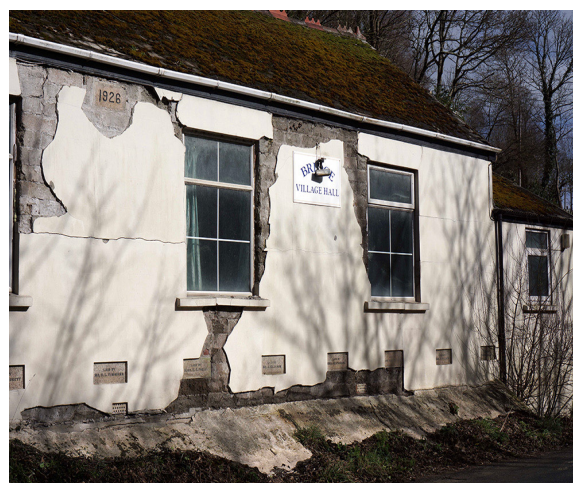
Figure 3: Photographs of two different properties exhibiting characteristic mundic damage

relevant limitations to the inspection, for example, weather conditions. Some examples of mundic-affected buildings are shown in Figure 3.

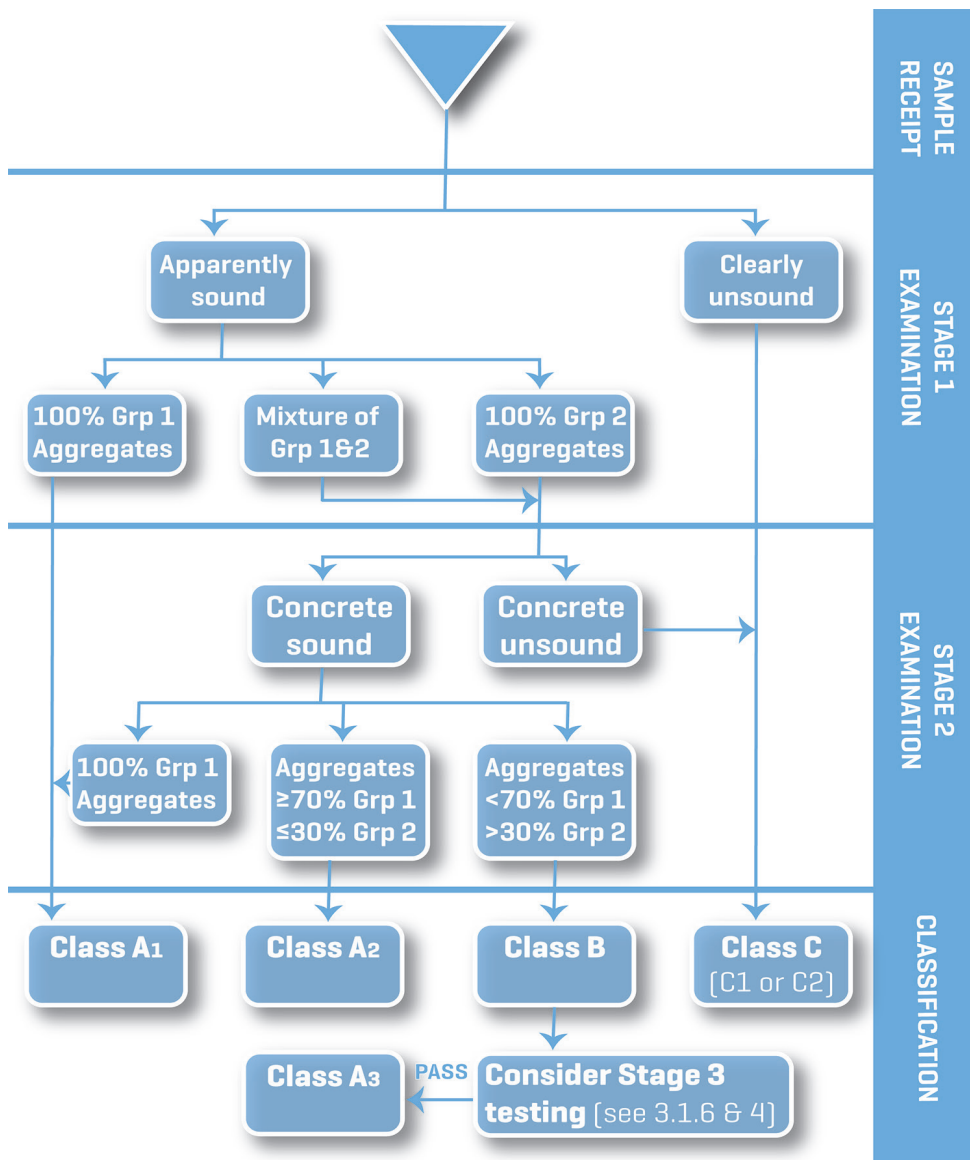
Figure 4: Examination and classification procedure

Note: The flow chart is simplified and reference should be made to the full text.

3.1.3 This section describes the progressive phases in the examination of concrete. There are two stages of examination and a third testing stage (see sections 3.1.6 and 4). Not all of these examination stages will be required for every sample, and it is emphasised that the progressive procedure described here will be concluded when a satisfactory classification of the concrete can be made. An outline of the typical investigation procedure using Stages 1 and 2 is shown in Figure 4, which also indicates the potential outcome of Stage 3, as detailed in section 4.

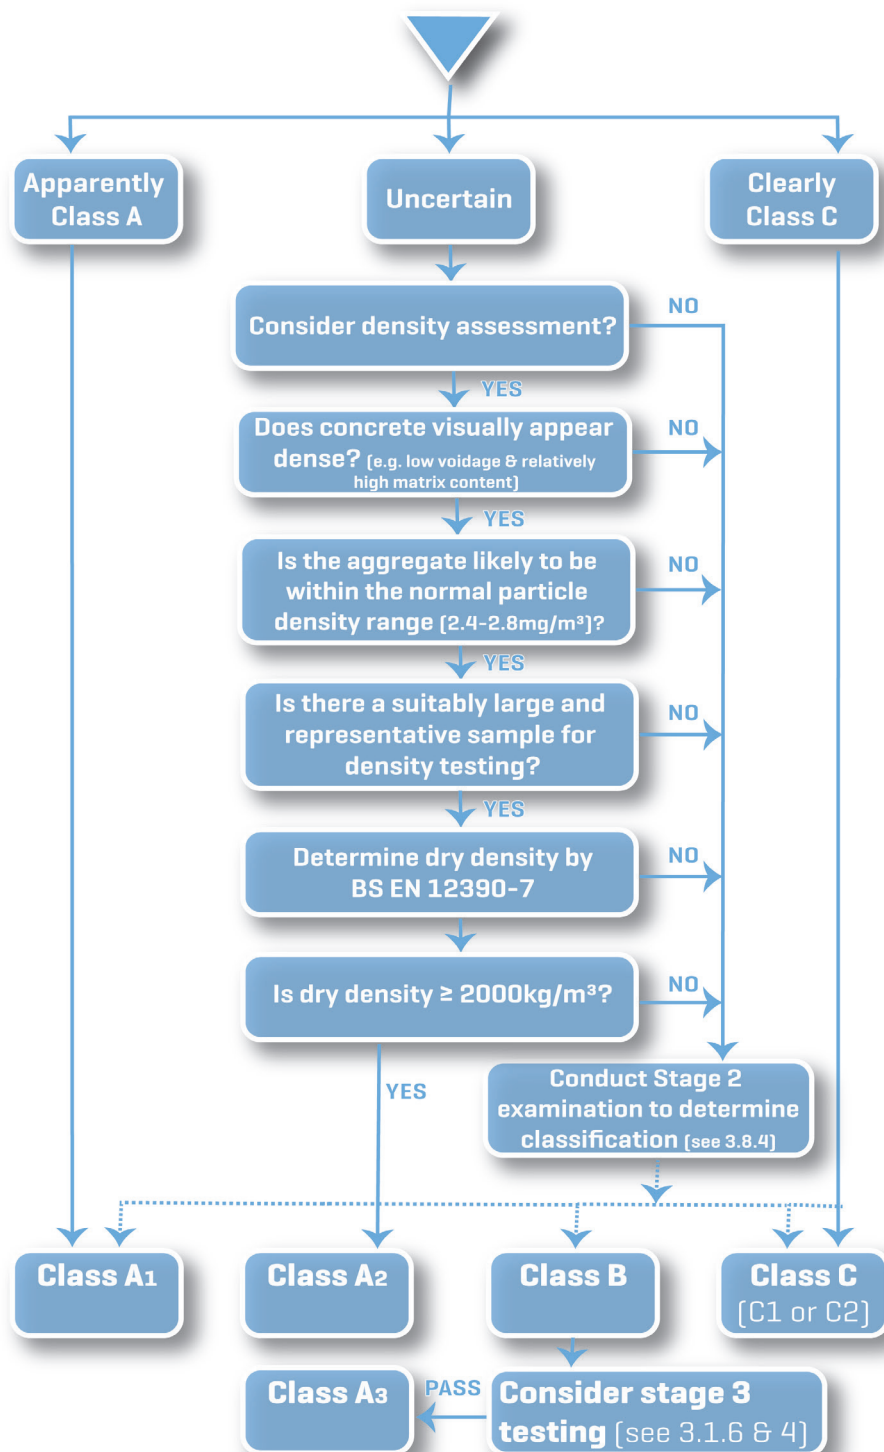
Figure 8: Flow chart showing special procedure for mass concrete footings

in accordance with BS EN 12390-7:2009.¹¹ This special procedure for mass concrete footings is outlined in Figure 8.

3.11.2 Samples exhibiting a dry density of 2000kg/m³ or more should be placed into Class A₂. Samples that do not appear dense and/or seem likely to contain either relatively heavyweight (say >2.8mg/m³) or lightweight (say <2.4mg/m³) aggregates, or tested samples exhibiting a dry density of less than 2000kg/m³ (unless reassessed as explained in sections 3.11.4 and 3.11.5), should be subjected to the Stage 2 examination procedure and classified accordingly (see sections 3.8 and especially 3.8.2).

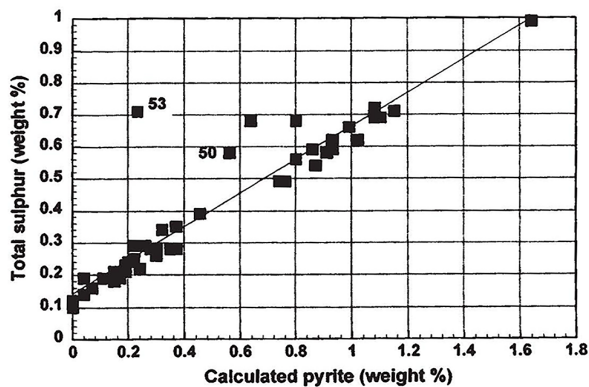
Figure D2 is a plot of calculated pyrite v. total sulphur. Most analyses lie very close to the regression line, which indicates that in the majority of cases pyrite has suffered very little in situ oxidation. The regression line intersects the Y-axis at approximately 0.12% S. This probably represents original sulphur present in the cement as sulphate. Analyses that plot above the regression line are from specimens which contain excess sulphate formed by the oxidation of pyrite. This is supported by petrographic study of specimens 50 and 53 which show strongly oxidised pyrite, limonite-impregnated cement, and in the case of specimen 53, secondary gypsum growth in voids.

Figure D2: Plot of calculated pyrite v. total sulphur in 54 concrete blocks made with Penlee aggregate

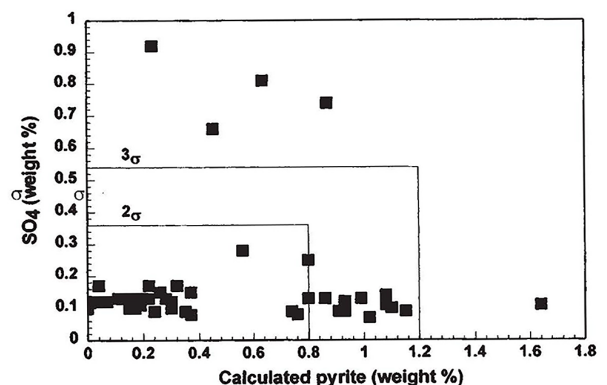
Figure D4 is a plot of calculated pyrite v. sulphate (as SO₄). The boxes define regions in which calculated pyrite content and sulphate (as SO₄) are less than 2σ and 3σ respectively. The 2σ box encloses 37 (approx. 70%) of the analyses, including all of the low pyrite–low sulphate population. The 2σ pyrite line intersects the high pyrite population and its boundary might be lowered to about 0.6%. The 3σ box includes all but the specimen with highest pyrite content and four specimens with excess sulphate and which show clear evidence of in situ pyrite oxidation.

Figure D4: Plot of calculated Pyrite v. sulphate in 54 analysed samples of concrete made with Penlee aggregate. The boxes labelled 2σ and 3σ define compositions where pyrite and sulphate concentrations are less than 2σ and 3σ standard deviations respectively

In concrete made with all-in Penlee metadolerite aggregate, one of the following safe limits might be advisable for sulphate and calculated pyrite concentrations:

- 0.6% pyrite and 0.4% sulphate (approx. 2σ). This is a very safe option but it would exclude many properties built with Penlee aggregate blocks in which there is no evidence of general concrete deterioration that might be ascribed to in situ pyrite oxidation.
- 1.2% pyrite and 0.6% sulphate (approx. 3σ). This would include many properties made with concrete having high pyrite concentrations but exclude the small number in which there is obvious evidence of sulphide-related concrete degradation.
